HYUNDAI NEW THINKING. NEW POSSIBILITIES. Technical Service Bulletin	GROUP	NUMBER
	AUTOMATIC TRANSMISSION	13-AT-012-1
	DATE	MODEL
	SEPTEMBER 2013	Tucson (LM), Santa Fe (CM/AN/NC), Sonata (YF), Elantra (UD/MD/GD/JK), Accent (RB), Azera (TG/HG), Veloster Turbo (FS)
SUBJECT:	AUTOMATIC TRANSAXLE (6-SPEED) OIL TEMPERATURE SENSOR DTC P0711, P0712 & P0713

This TSB supersedes bulletin 13-AT-012 to add Op Codes.

Description: Do not replace the transaxle for the DTC listed below. Instead, follow the repair procedure and replace the related part.

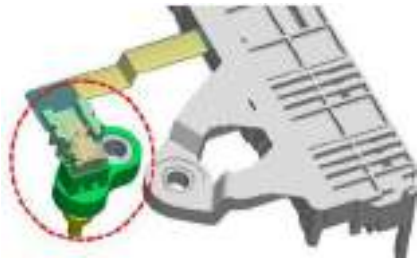
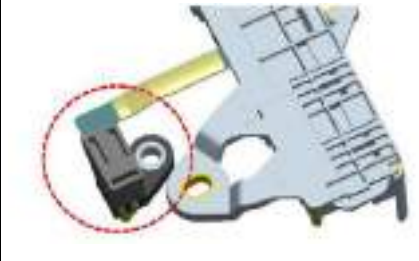
The oil temperature sensor has been integrated with the internal harness from early March, 2013. The oil temperature sensor is not available separately for these models.

Previous (separate parts)	New (integrated parts)
Oil temperature sensor and internal harness

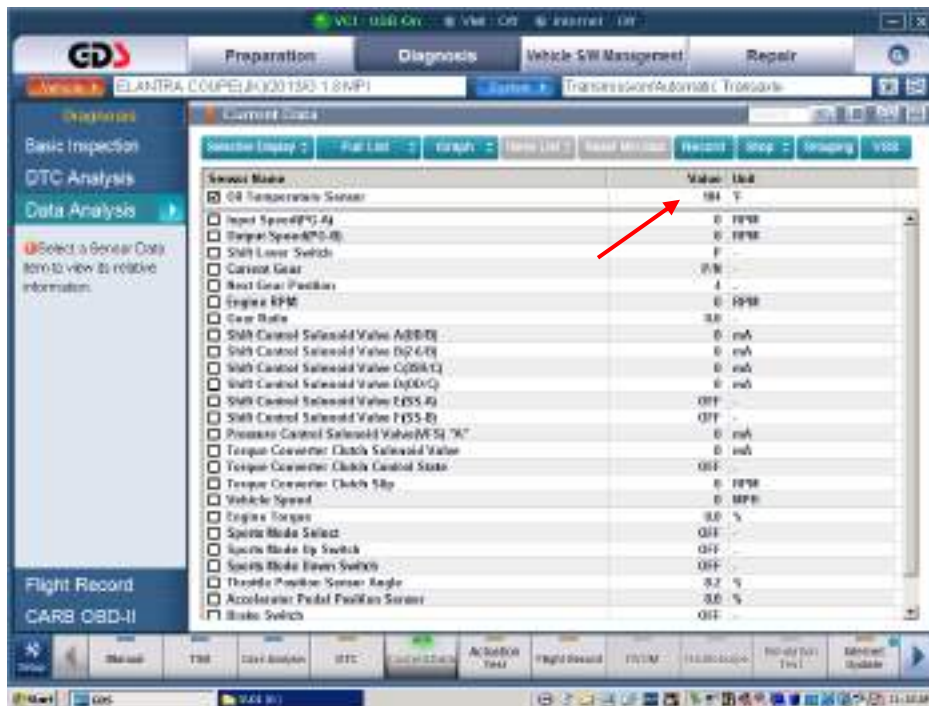
1. Using a GDS, check for DTC in the “Automatic Transaxle” menu. **Record the DTC and description.** Delete the DTC.
2. From the GDS, select the following parameters. Drive the vehicle and monitor the sensors.
 - Vehicle and A/T menu.
 - “Current Data”
 - Oil temperature sensor.
